Flood Control Project Maintenance
2018 Structure Summary Report
Overall Unit and Item Ratings

City of Sacramento

El Camino Avenue Bridge

Magpie Creek Pumping Plant

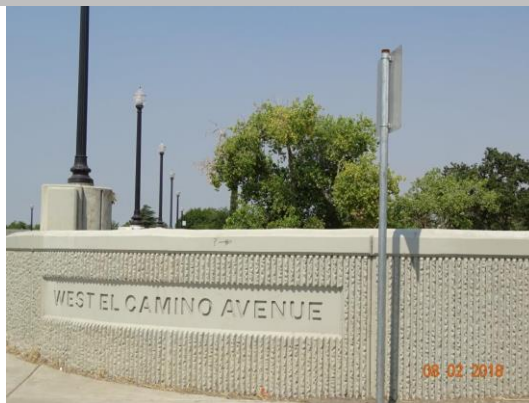
Photo 1 of 6 : ST_2018_NA0005_221_1_20180803_00014.jpg

| Inspector Comments: West El Camino bridge is inspected as a structure because the bridge deck is below the design water surface elevation causing the wingwalls and guard railing to act as flood walls during high water events. | | | | | |

View of the east end of the bridge. Summer 2018

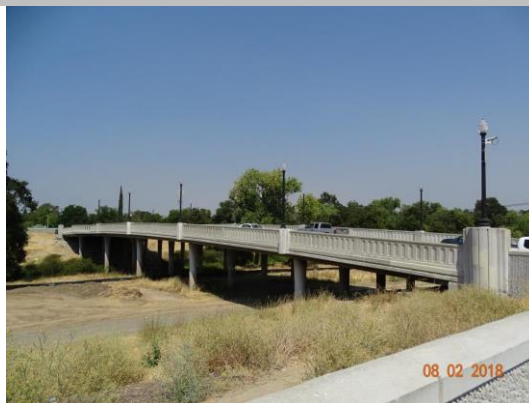
Photo 2 of 6 : ST_2018_NA0005_221_1_20180803_00016.jpg

View of the downstream side of the bridge from the left bank. Summer 2018

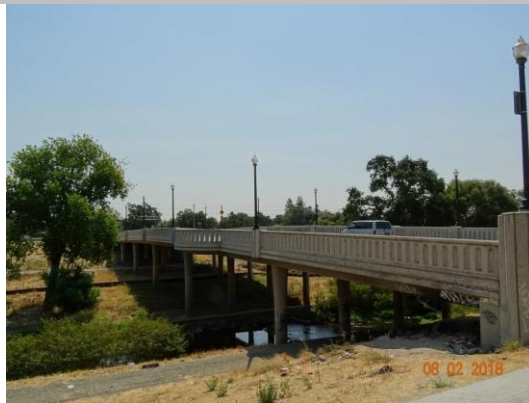
Photo 3 of 6 : ST_2018_NA0005_221_1_20180803_00015.jpg

View of the upstream side of the bridge from the right bank. Summer 2018

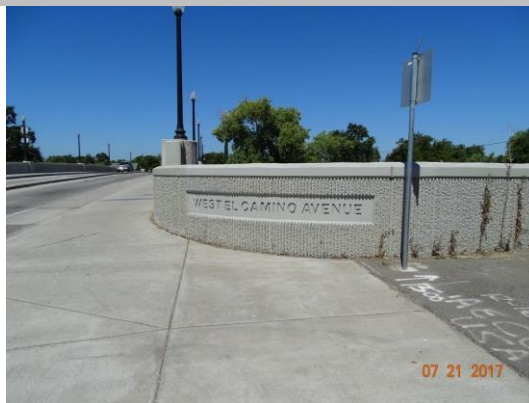
Photo 4 of 6 : ST_2018_NA0005_221_1_20180601_00001.jpg

View of the beginning of the bridge. Summer 2017

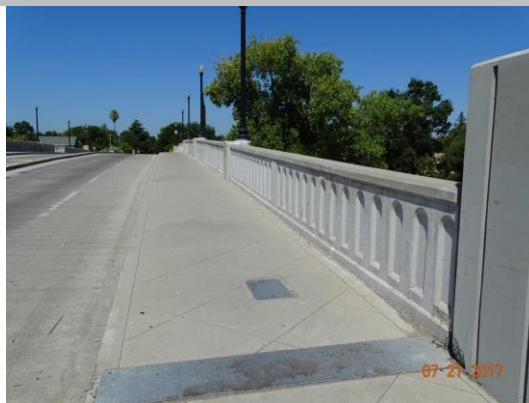
Photo 5 of 6 : ST_2018_NA0005_221_1_20180601_00002.jpg

View of the wing wall to act as a flood wall at this structure. Summer 2017

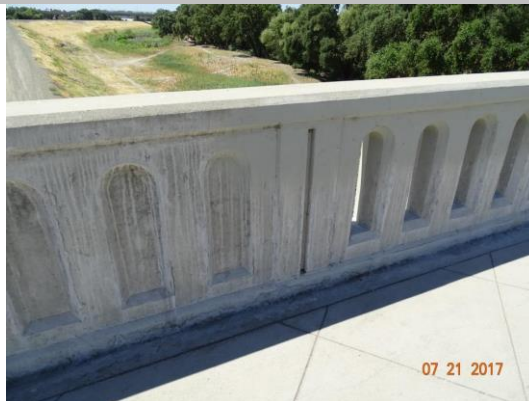
Photo 6 of 6 : ST_2018_NA0005_221_1_20180601_00003.jpg

View of the separation between wingwall that act as a flood wall and guard rail at the middle of the bridge. Summer 2017

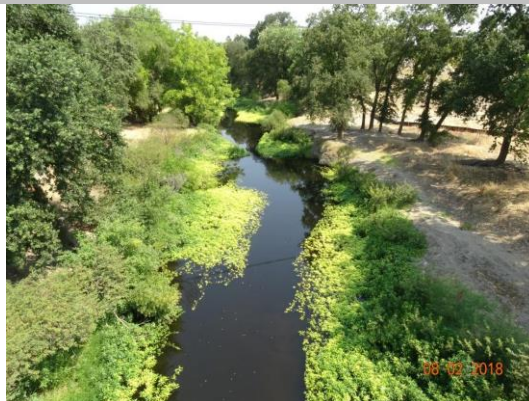
Photo 1 of 4 : ST_2018_NA0005_221_2_20180803_00017.jpg

| Inspector Comments: The channel appeared to be free of any vegetation growth that would impede flows. | | | | | |

View of upstream vegetation. Summer 2018

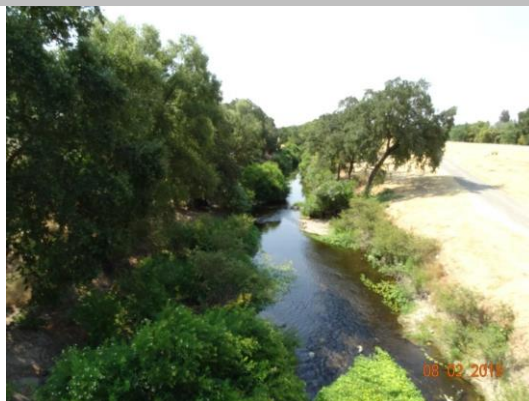
Photo 2 of 4 : ST_2018_NA0005_221_2_20180803_00018.jpg

View of downstream vegetation. Summer 2018

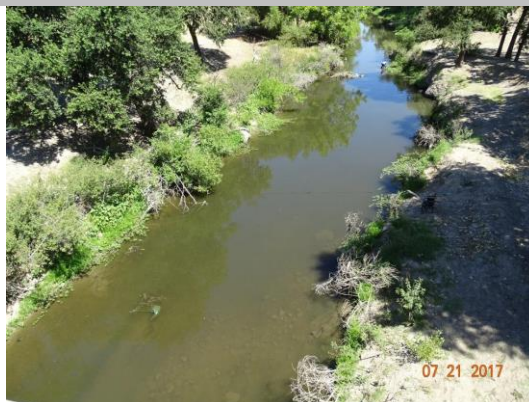
Photo 3 of 4 : ST_2018_NA0005_221_2_20180601_00004.jpg

View of the channel under the bridge looking upstream. Summer 2017

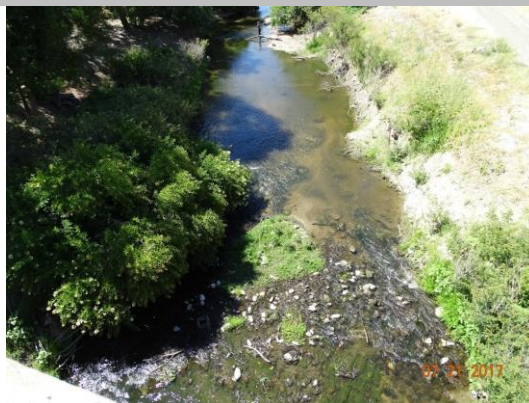
Photo 4 of 4 : ST_2018_NA0005_221_2_20180601_00005.jpg

View of the channel under the bridge looking downstream. Summer 2017

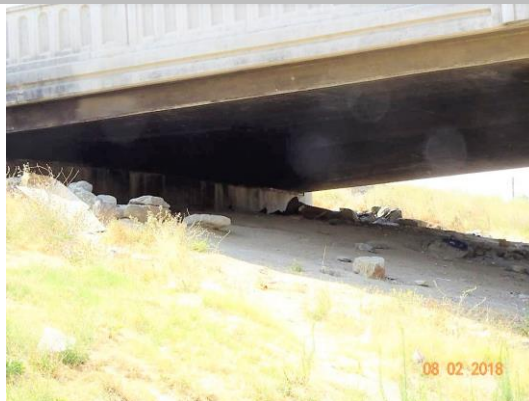
Photo 1 of 2 : ST_2018_NA0005_221_5_20180803_00019.jpg

| Inspector Comments: Riprap underneath the bridge appears to be displaced by others. | | | | | |

View of revetment underneath the east end of the bridge. Summer 2018

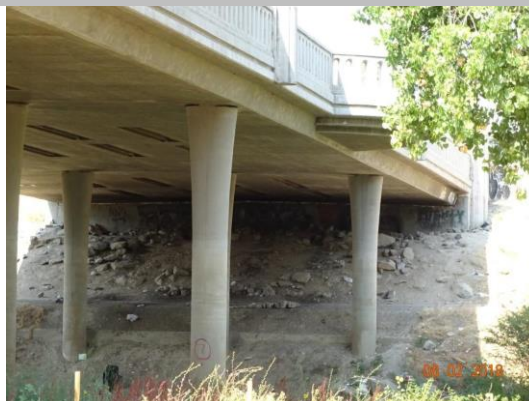
Photo 2 of 2 : ST_2018_NA0005_221_5_20180803_00020.jpg

View of revetment underneath the west end of the bridge. Summer 2018

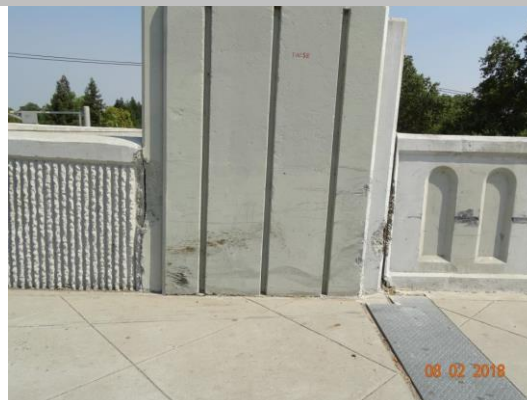
Photo 1 of 4 : ST_2018_NA0005_221_15_20180803_00021.jpg

| Inspector Comments: There is minor spalling along the northwest end of the bridge. | | | | | |

View of minor spalling at northwest end of the bridge. Summer 2018

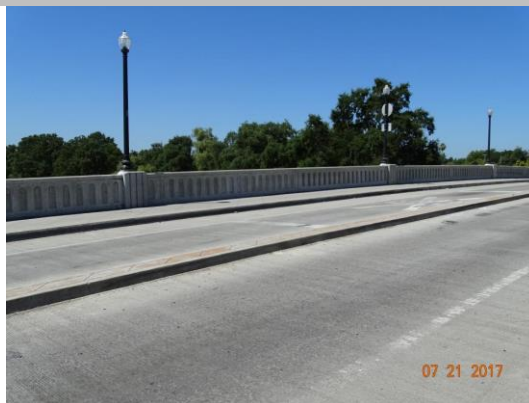
Photo 2 of 4 : ST_2018_NA0005_221_15_20180601_00006.jpg

View of the flood wall. Summer 2017

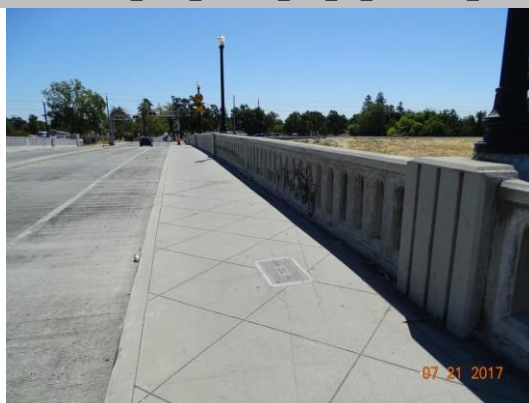
Photo 3 of 4 : ST_2018_NA0005_221_15_20180601_00007.jpg

View of the guard rail of the bridge. Summer 2017

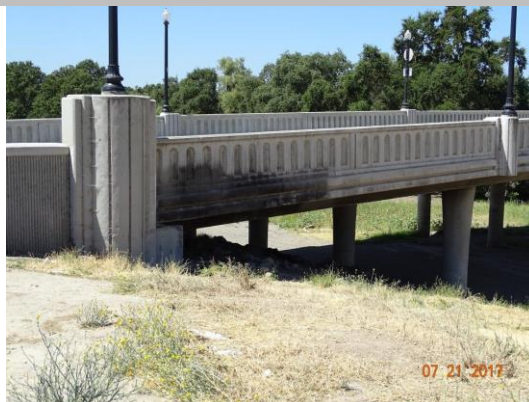
Photo 4 of 4 : ST_2018_NA0005_221_15_20180601_00008.jpg

View of the flood wall that appears to have smoke damage, but the joints and the integrity of the wall don't appear to be threatened. Summer 2017

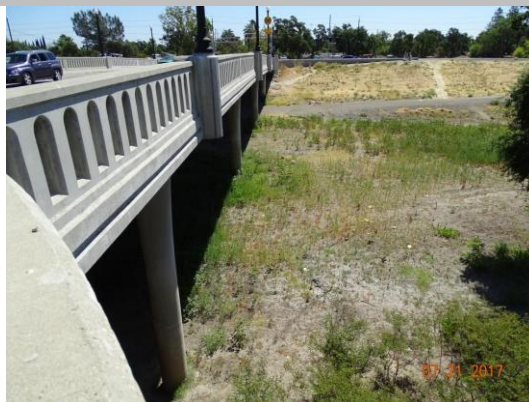
Photo 1 of 2 : ST_2018_NA0005_221_17_20180601_00009.jpg

| Inspector Comments: No apparent scouring or erosion at the footings of the structure. | | | | | |

View of the columns of the bridge looking upstream.

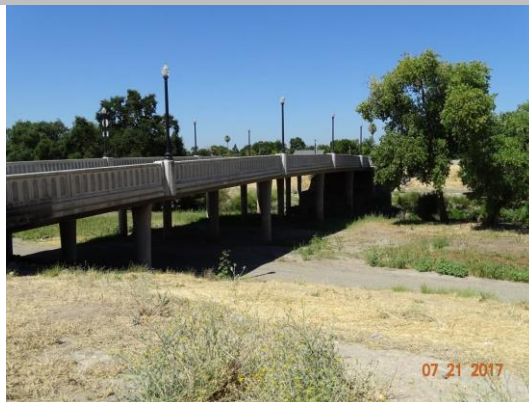
Photo 2 of 2 : ST_2018_NA0005_221_17_20180601_00010.jpg

View below the bridge looking toward downstream.

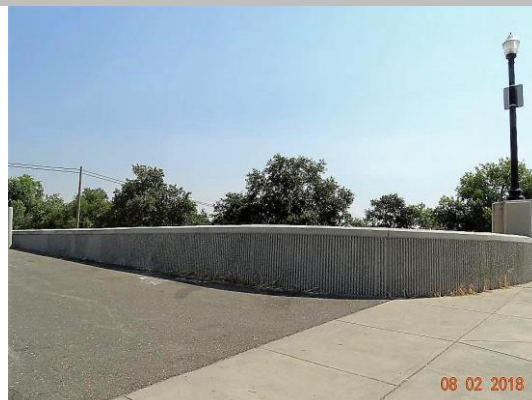
Photo 1 of 4 : ST_2018_NA0005_221_22_20180803_00022.jpg

View of the flood wall at the northwest end of the bridge. Summer 2018

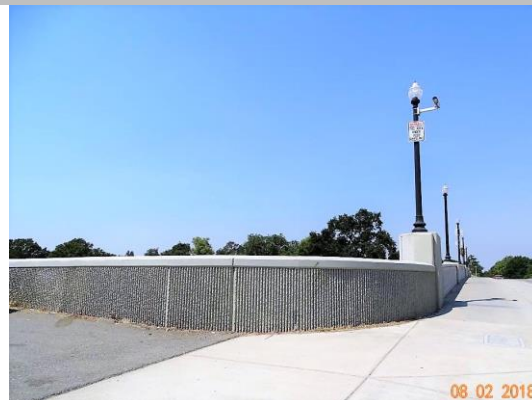
Photo 2 of 4 : ST_2018_NA0005_221_22_20180803_00023.jpg

View of the flood wall at the southeast end of the bridge. Summer 2018

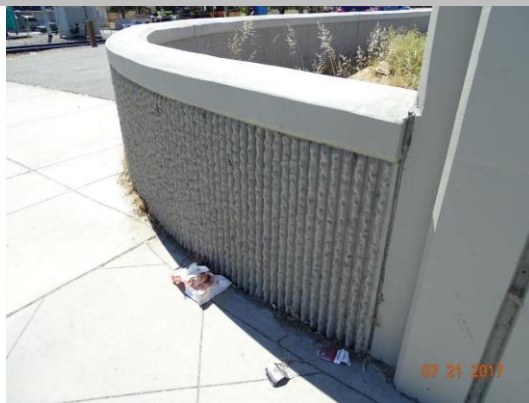
Photo 3 of 4 : ST_2018_NA0005_221_22_20180601_00011.jpg

View of the flood walls with monolith joints. Summer 2017

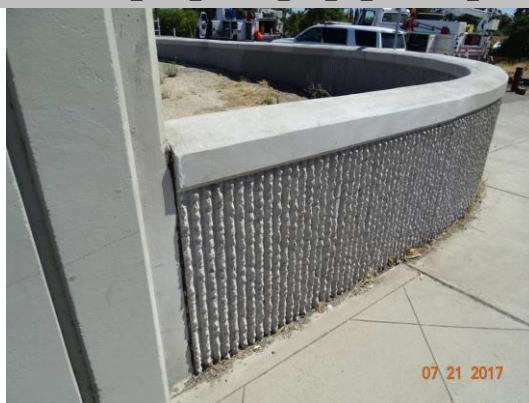
Photo 4 of 4 : ST_2018_NA0005_221_22_20180601_00012.jpg

View of the flood walls with monolith joints. Summer 2017

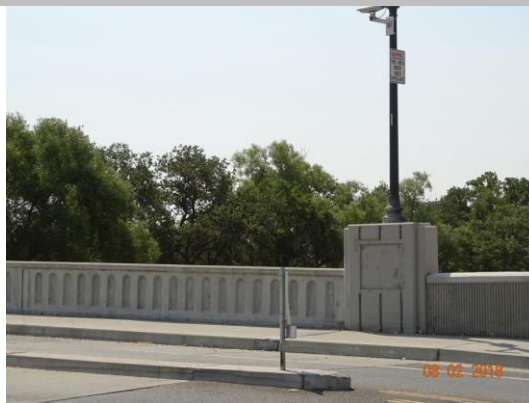
Photo 1 of 3 : ST_2018_NA0005_221_23_20180803_00024.jpg

View of the guard rails. Summer 2018

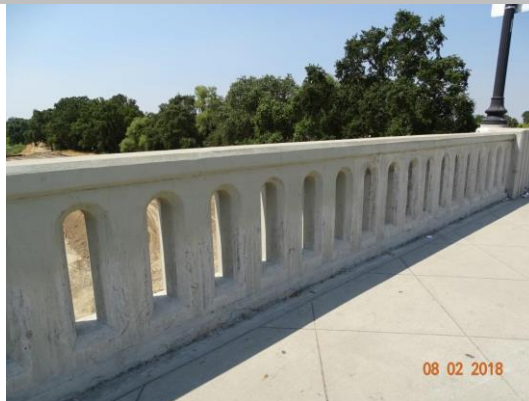
Photo 2 of 3 : ST_2018_NA0005_221_23_20180803_00025.jpg

View of the guard rails. Summer 2018

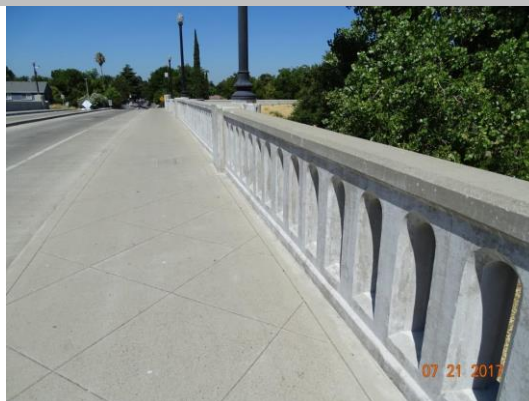
Photo 3 of 3 : ST_2018_NA0005_221_23_20180601_00013.jpg

View of the guard rails which provides protection against fall hazards.
Summer 2017

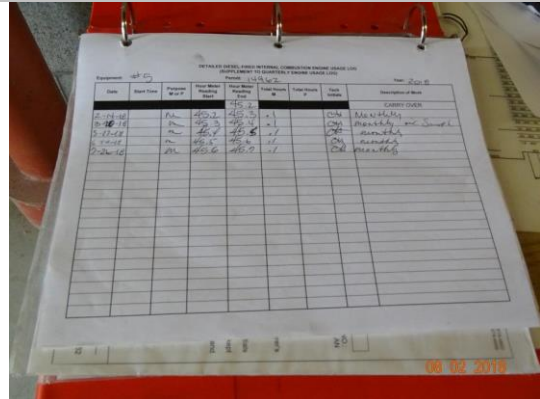
Photo 1 of 1 : ST_2018_NA0005_16_1_20180803_00027.jpg

| Inspector Comments: The operation log shows preventive maintenance activities for the engines, and the maintenance records show activities following their prescribed frequencies. | | | | | |

View of the maintenance log at the station. Summer 2018

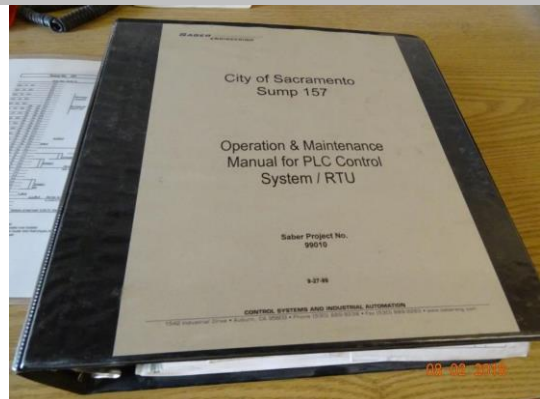
Photo 1 of 2 : ST_2018_NA0005_16_2_20180803_00028.jpg

| Inspector Comments: The City of Sacramento doesn't have the O&M manual for this plant. This pumping plant is listed in the SPFC Descriptive Document as a SPFC pumping plant. CVFPB permit #9596 was issued to construct this structure. | | | | | |

View of the O&M manual for the PLC Control System/RTU. Summer 2018

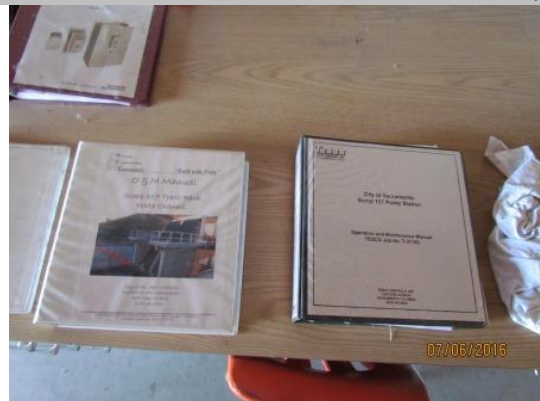
Photo 2 of 2 : ST_2018_NA0005_16_2_20180601_00002.jpg

View of O&M manuals in the plant, but they are not written by the USACE. Summer 2017

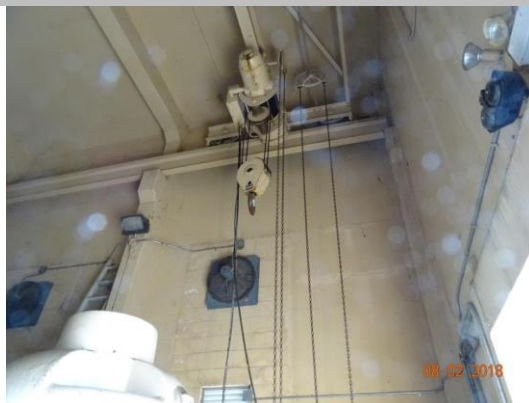
Photo 1 of 1 : ST_2018_NA0005_16_6_20180803_00033.jpg

| Inspector Comments: Hoist and monorail system was tested and appear to be functional. Annual CAL/OSHA Crane Certification completed. | | | | | |

View of the hoist and monorail system. Summer 2018

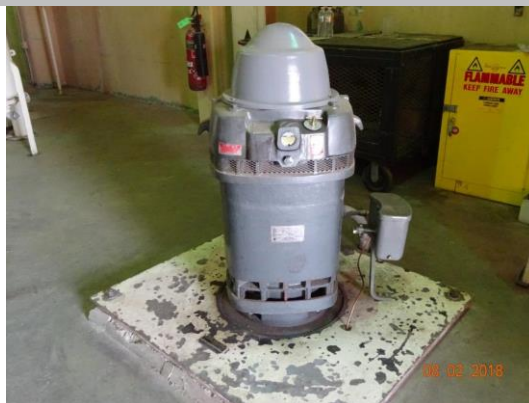
Photo 1 of 5 : ST_2018_NA0005_16_7_20180803_00034.jpg

| Inspector Comments: All pumps are available and in service. | | | | | |

View of small electric pump. Summer 2018

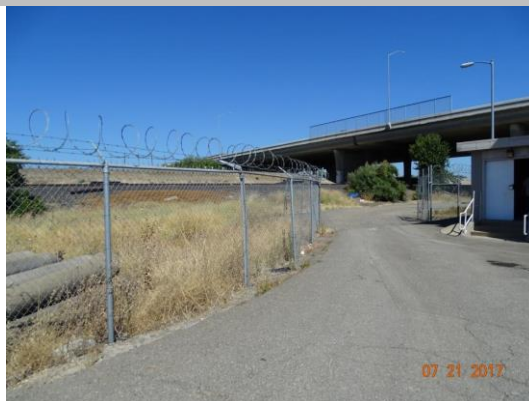
Photo 2 of 2 : ST_2018_NA0005_16_21_20180601_00024.jpg

View of the security fencing around the structure. Summer 2017
